HEALTH CONSULTATION

**North Ridge Estates
(a.k.a. Former Marine Recuperational Barracks)**

**T38S, Section 15, R9EWM
Northridge Drive, Hunters Ridge Road, Old Fort Road
Klamath Falls, Oregon 97603
Klamath County, Oregon**

**Prepared by the
Oregon Department of Human Services
Superfund Health Investigation and Education Program
Under Cooperative Agreement with the
U.S. Department of Health and Human Services
Agency for Toxic Substances and Disease Registry**

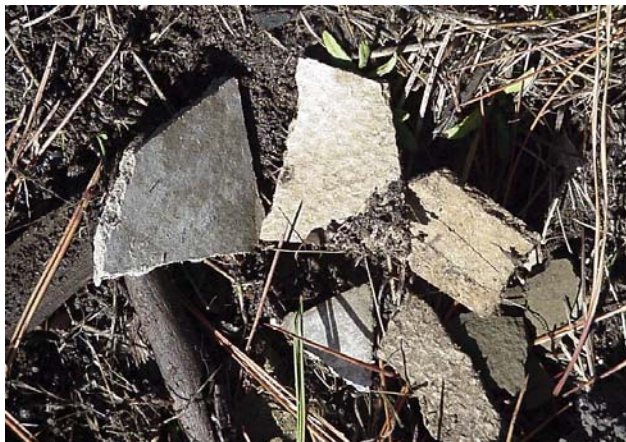
Figure 6: Cement Asbestos Board

Cement Asbestos Board (CAB) was used as siding on the former Marine Barracks buildings. CAB is platy in shape with a light to dark brown color; some of the CAB at the site had been painted with light green and yellow paint.

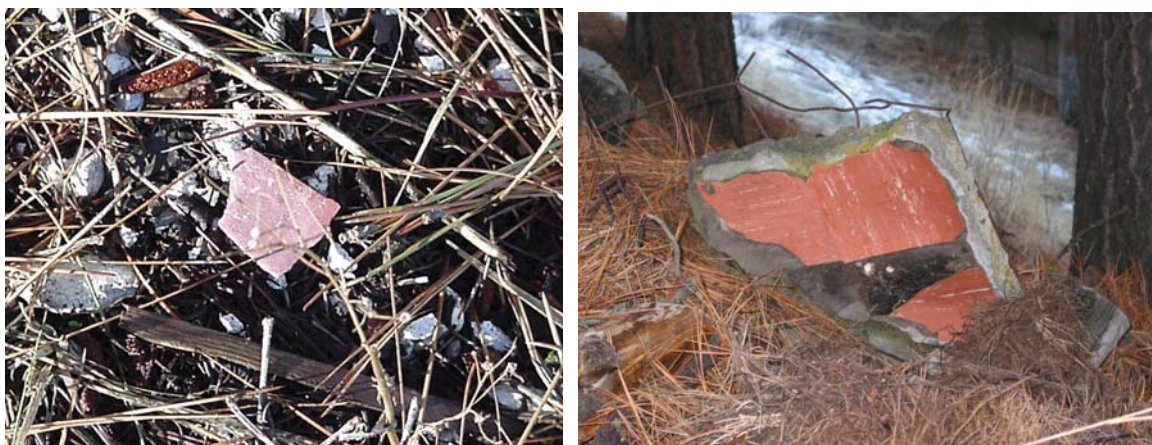
Figure 7: Vinyl Floor Tile

Vinyl floor tiles (VAT) are 9 by 9 inch tiles that were used on concrete and wooden floors of the former Marine Barracks buildings. Some tiles are red with white swirls, and others are blue. Broken VAT can come in many different platy shape sizes, and may have flat or curved shapes.

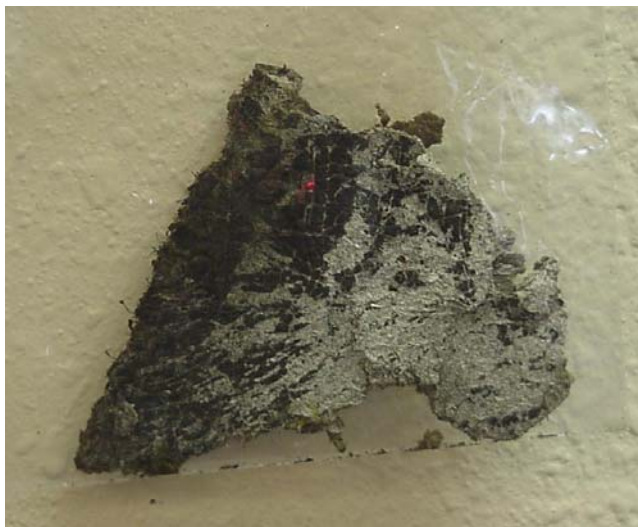
Figure 8: Roofing Material

Roofing material from the former Marine Barracks buildings is gray and black (the black material is tar).

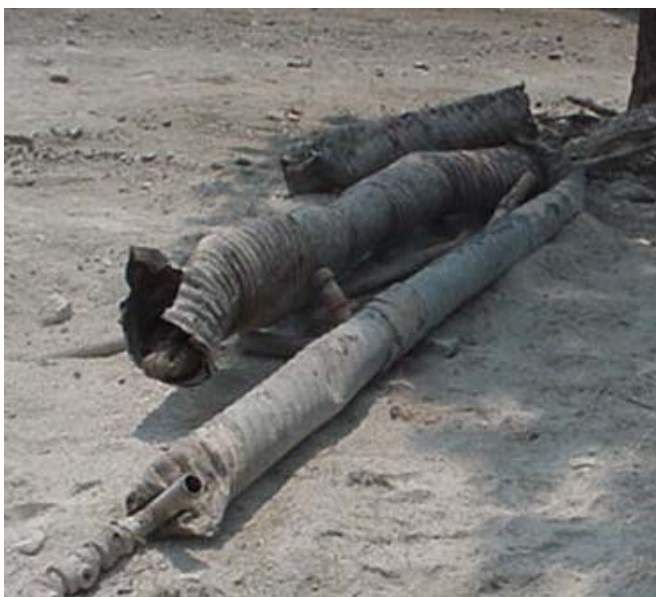
Figure 9: Asbestos-Containing Steam Pipe

Asbestos-containing steam pipe is located underground at the site from the former Marine Barracks steam power plant. The asbestos-containing steam pipe is a metal corrugated pipe (8 inches in diameter, in some places larger) wrapped in black felt paper (asbestos-containing). The inside of the corrugated pipe is lined with a black felt paper with about 2 inches of wooly material (90% asbestos). In the center of the wooly material is a metal pipe about 4 inches in diameter.

Underground steam piping from the former Marine Barracks has been located and mapped in some areas of the subdivision and in additional areas east and west of Old Fort Road in areas where former military buildings were heated by steam. This piping is wrapped on the inside and outside in ACM. The asbestos abatement contractor reported that piping is 24 inches below the surface [4]; however, at the January public meeting residents reported locating the piping at only 6 inches below the surface while doing yard work.

3. ODHS/SHINE recommends that, prior to any site-disturbing activities (such as construction or installation of utilities), the locations of underground asbestos-insulated piping be determined, and that dust mitigation be conducted during excavations, on any property within the footprint of the former developed area of the Marine Recuperational Barracks (including areas on the north and east sides of Old Fort Road). On properties where locations are known, ODHS recommends that locations be recorded on property deeds so that future property owners may avoid disturbing these areas.
